# **SOUTH DAKOTA SCIENCE AND TECHNOLOGY AUTHORITY**

## **REQUEST FOR PROPOSALS**

### **Restore Main Parking Lot Walkway Handrails**

#### **RFP #2022-28**

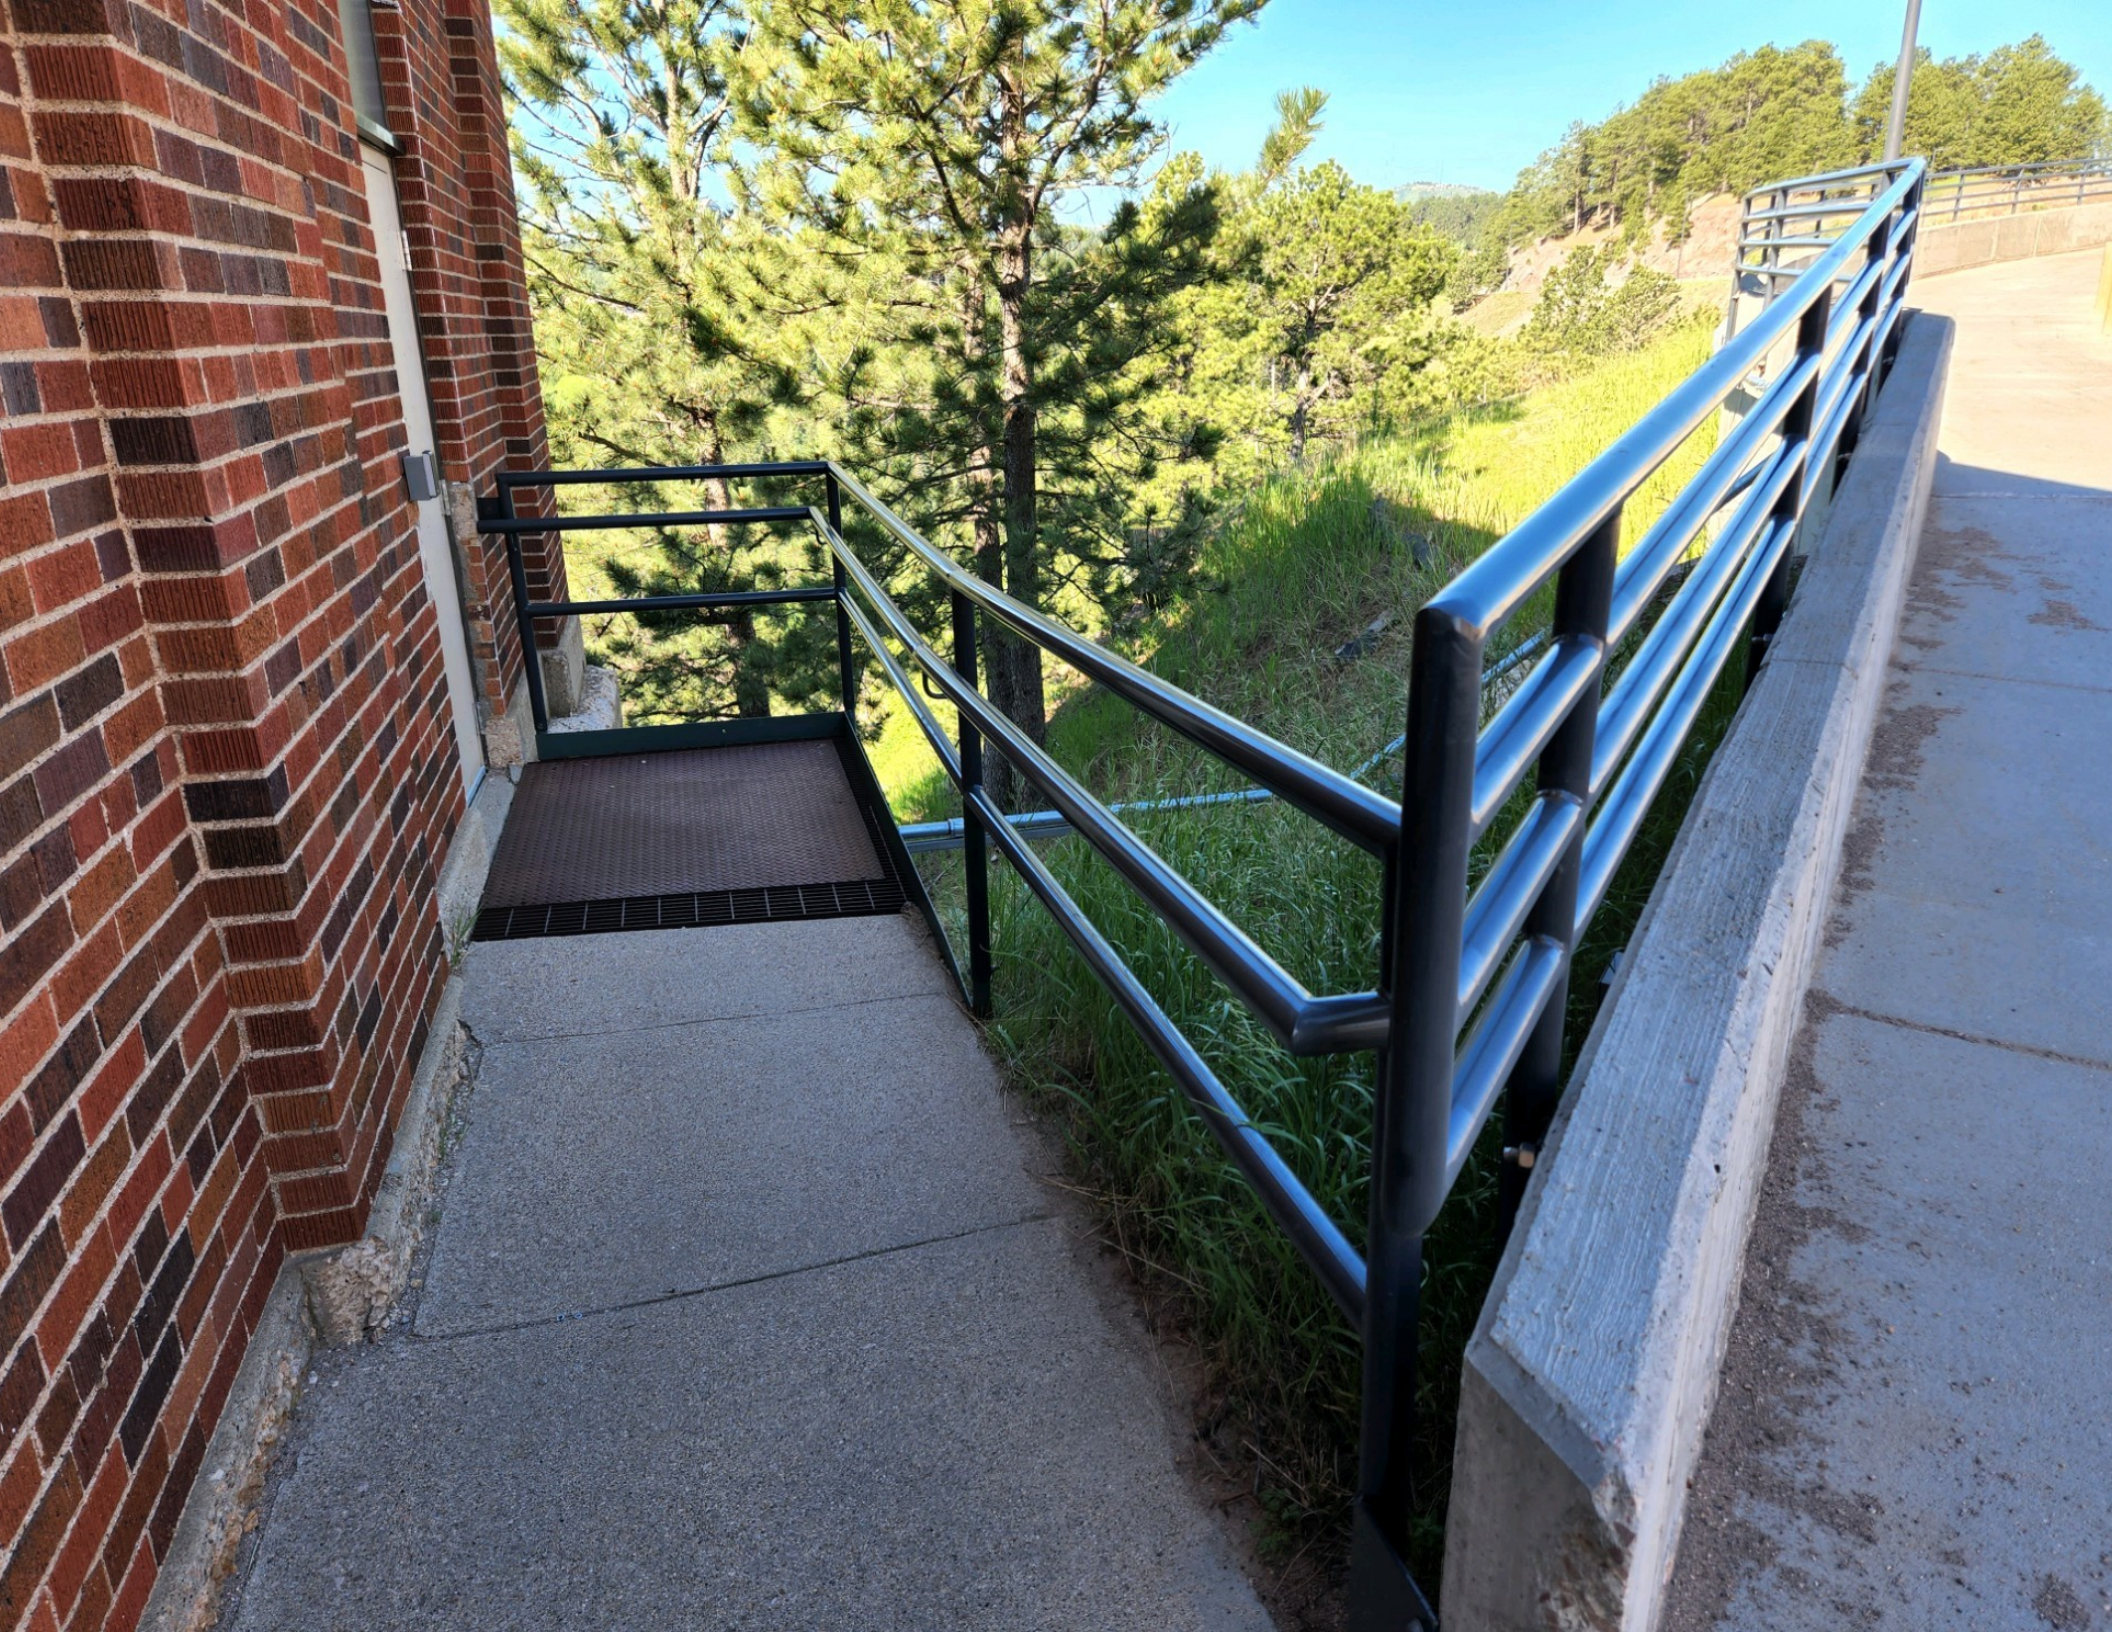
1. Picture 1: The section that connects to the rear door of the E&O Bldg. conference room.
  - a. Section is 3 pipes of about 18 feet long
  - b. The pipes are 1.5 inches in diameter with 3 up-rights
2. Picture 2: This section is from the E&O Bldg. up to the mid-point of the 2nd and 3rd light poles.
  - a. Section is 4 pipes that runs in several section totaling about 269 feet long
  - b. The pipes are 1.5 inches in diameter with up-rights spaced at about 6 to 8 feet apart
    - i. There are spaces between sections where the light poles are placed.
  - c. This section has most of the rusting problems
    - i. See pictures 3 and 4 that show some of the rusting corrosion spots.

1. Grind and spot prime the rusted/pitted areas with iron prime
2. Scuff handrails and brackets
3. Paint rails and brackets 1 color with 2 coats

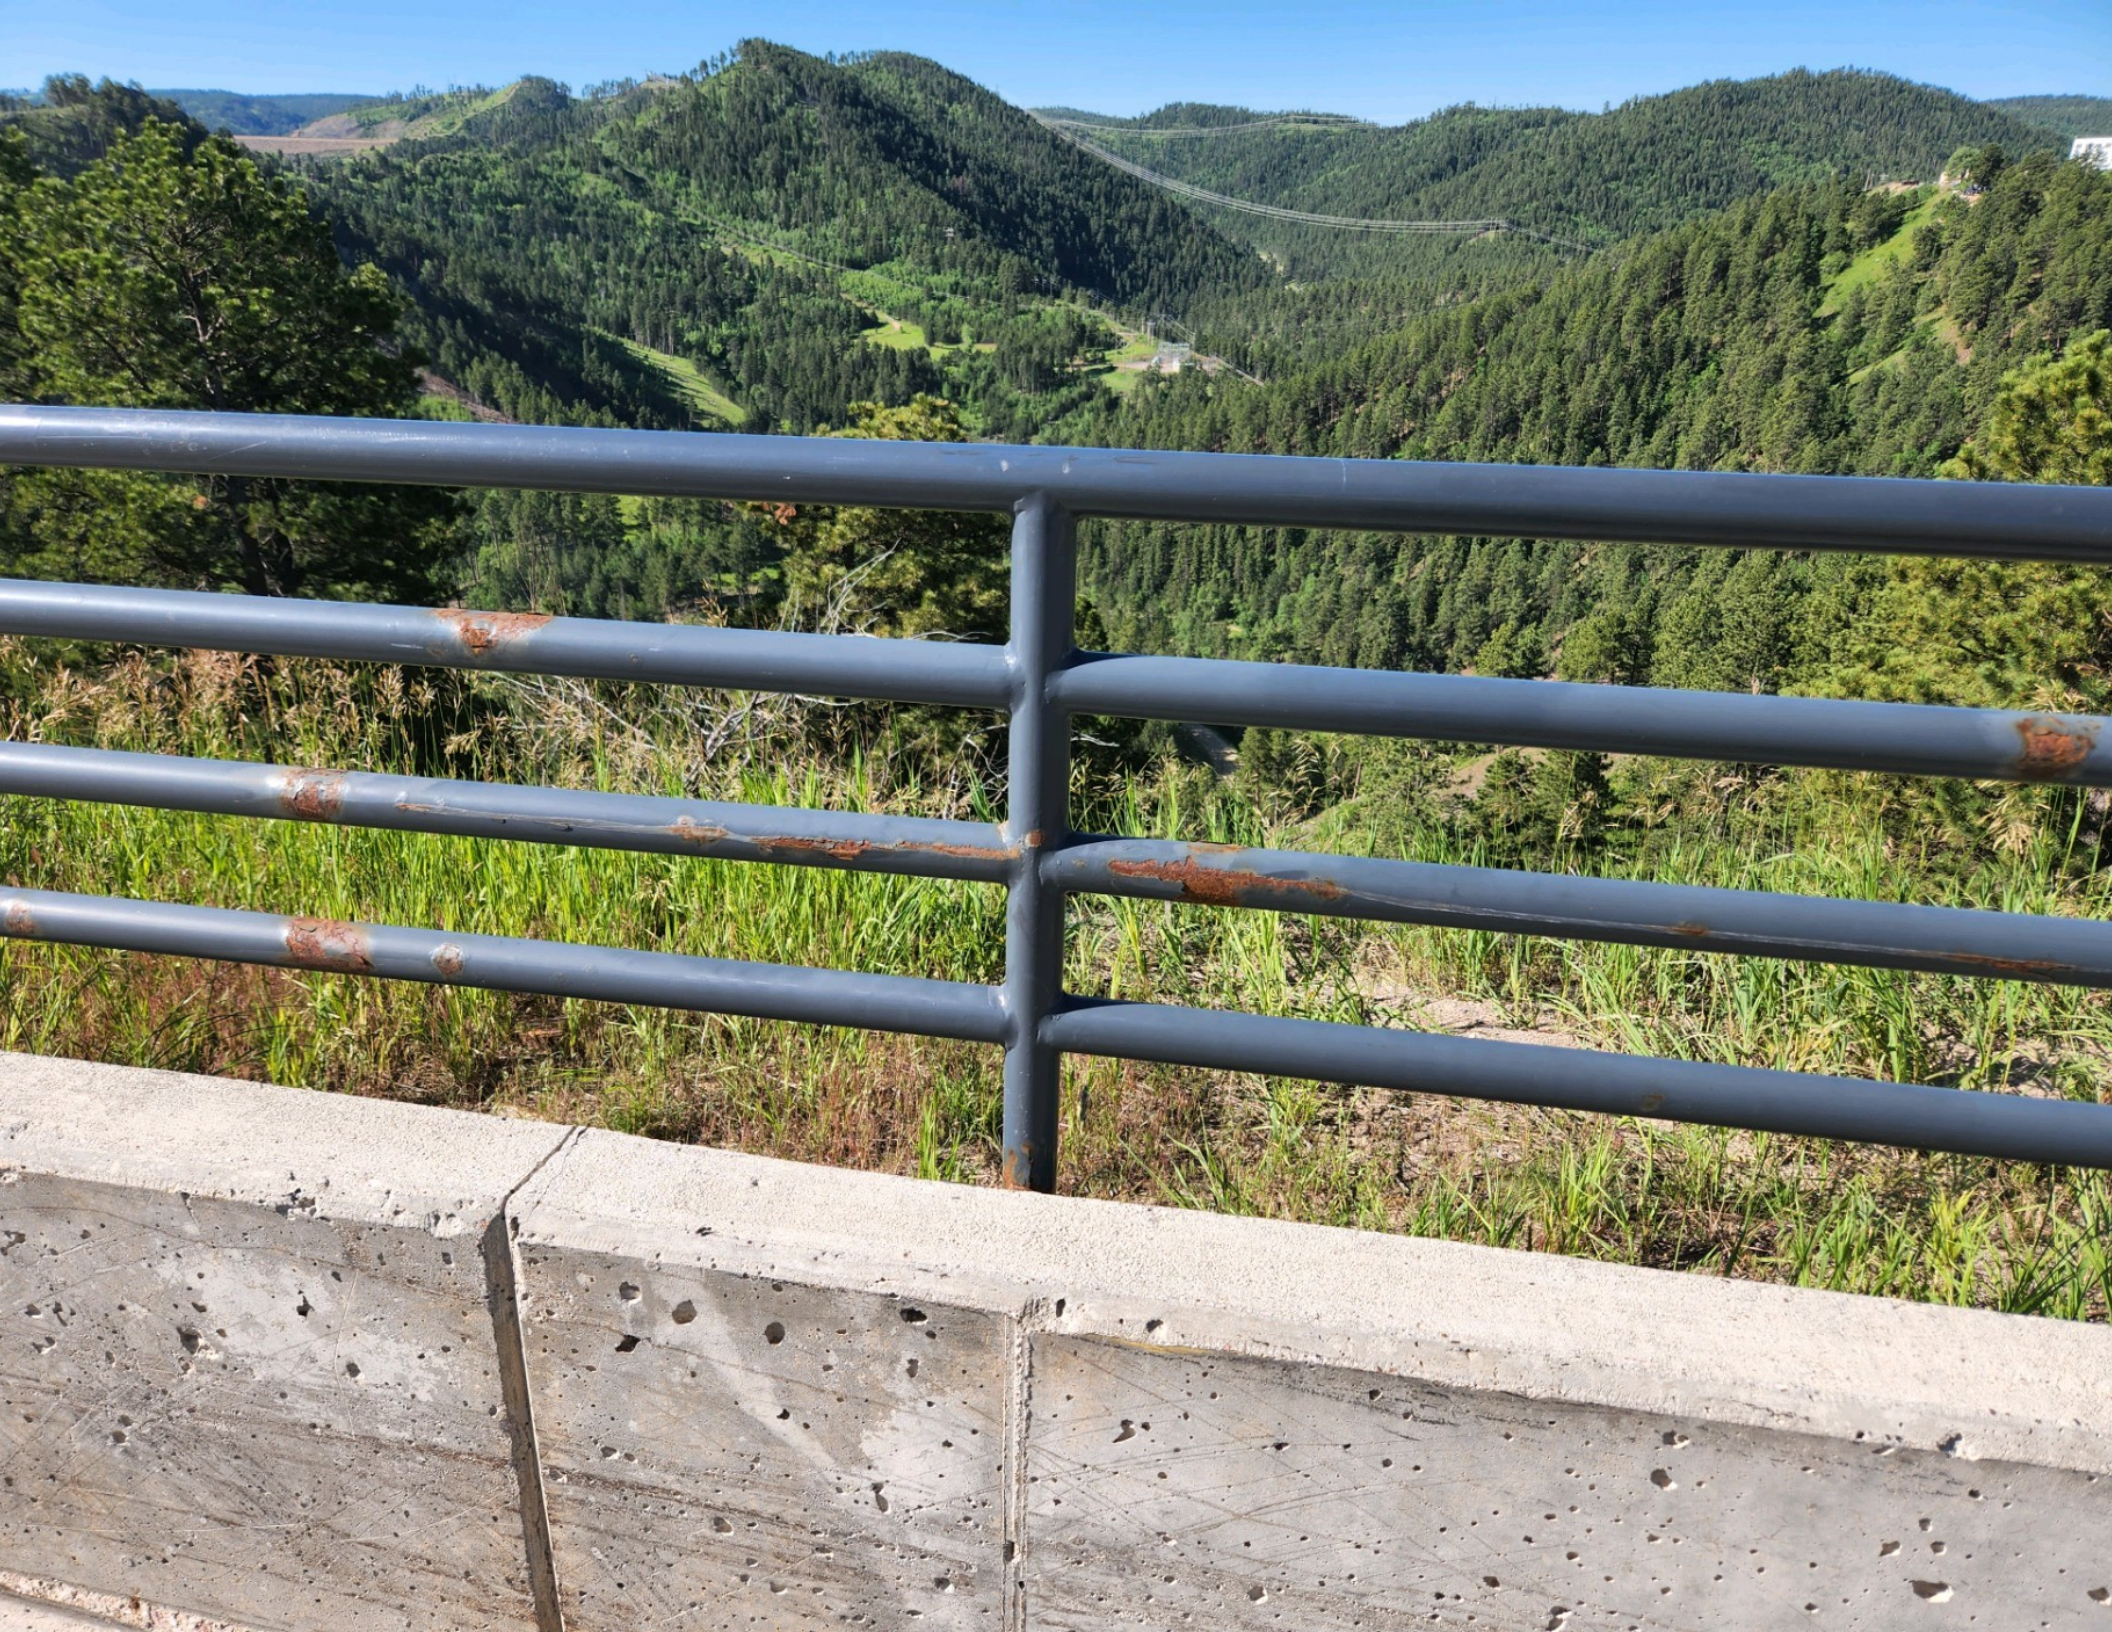
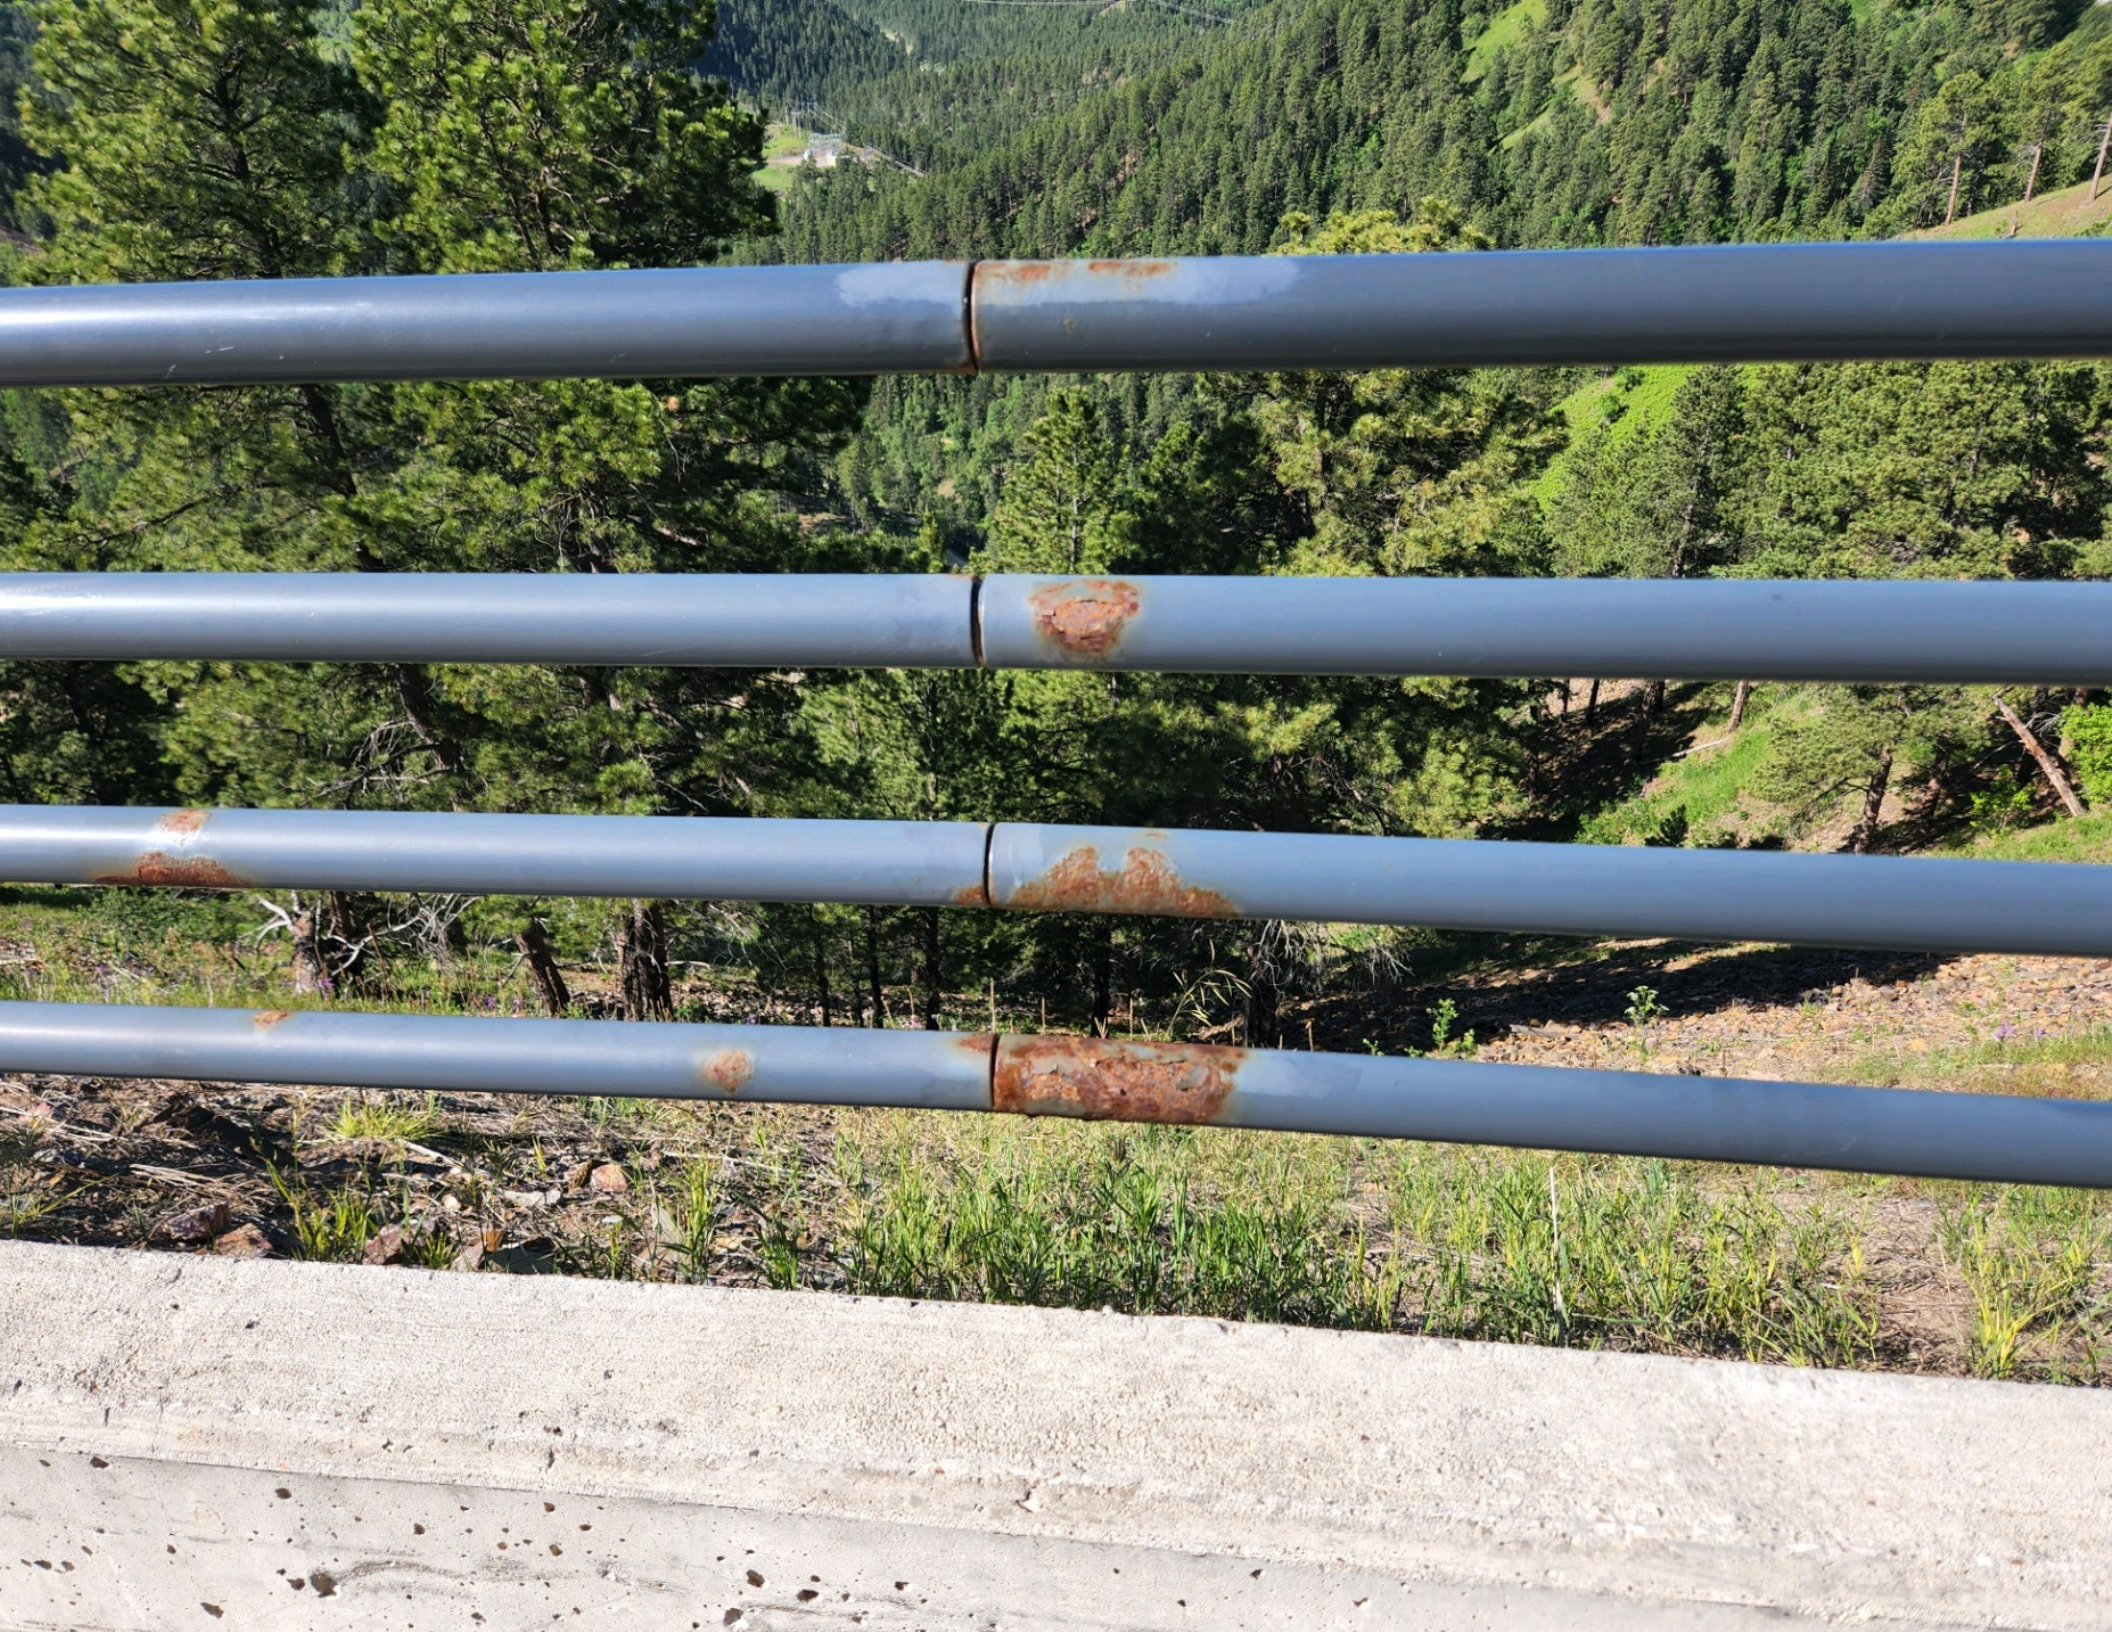
Current conditions could be harmful to the touch and range from rust to corrosion in certain areas. See pics for more detail on condition.

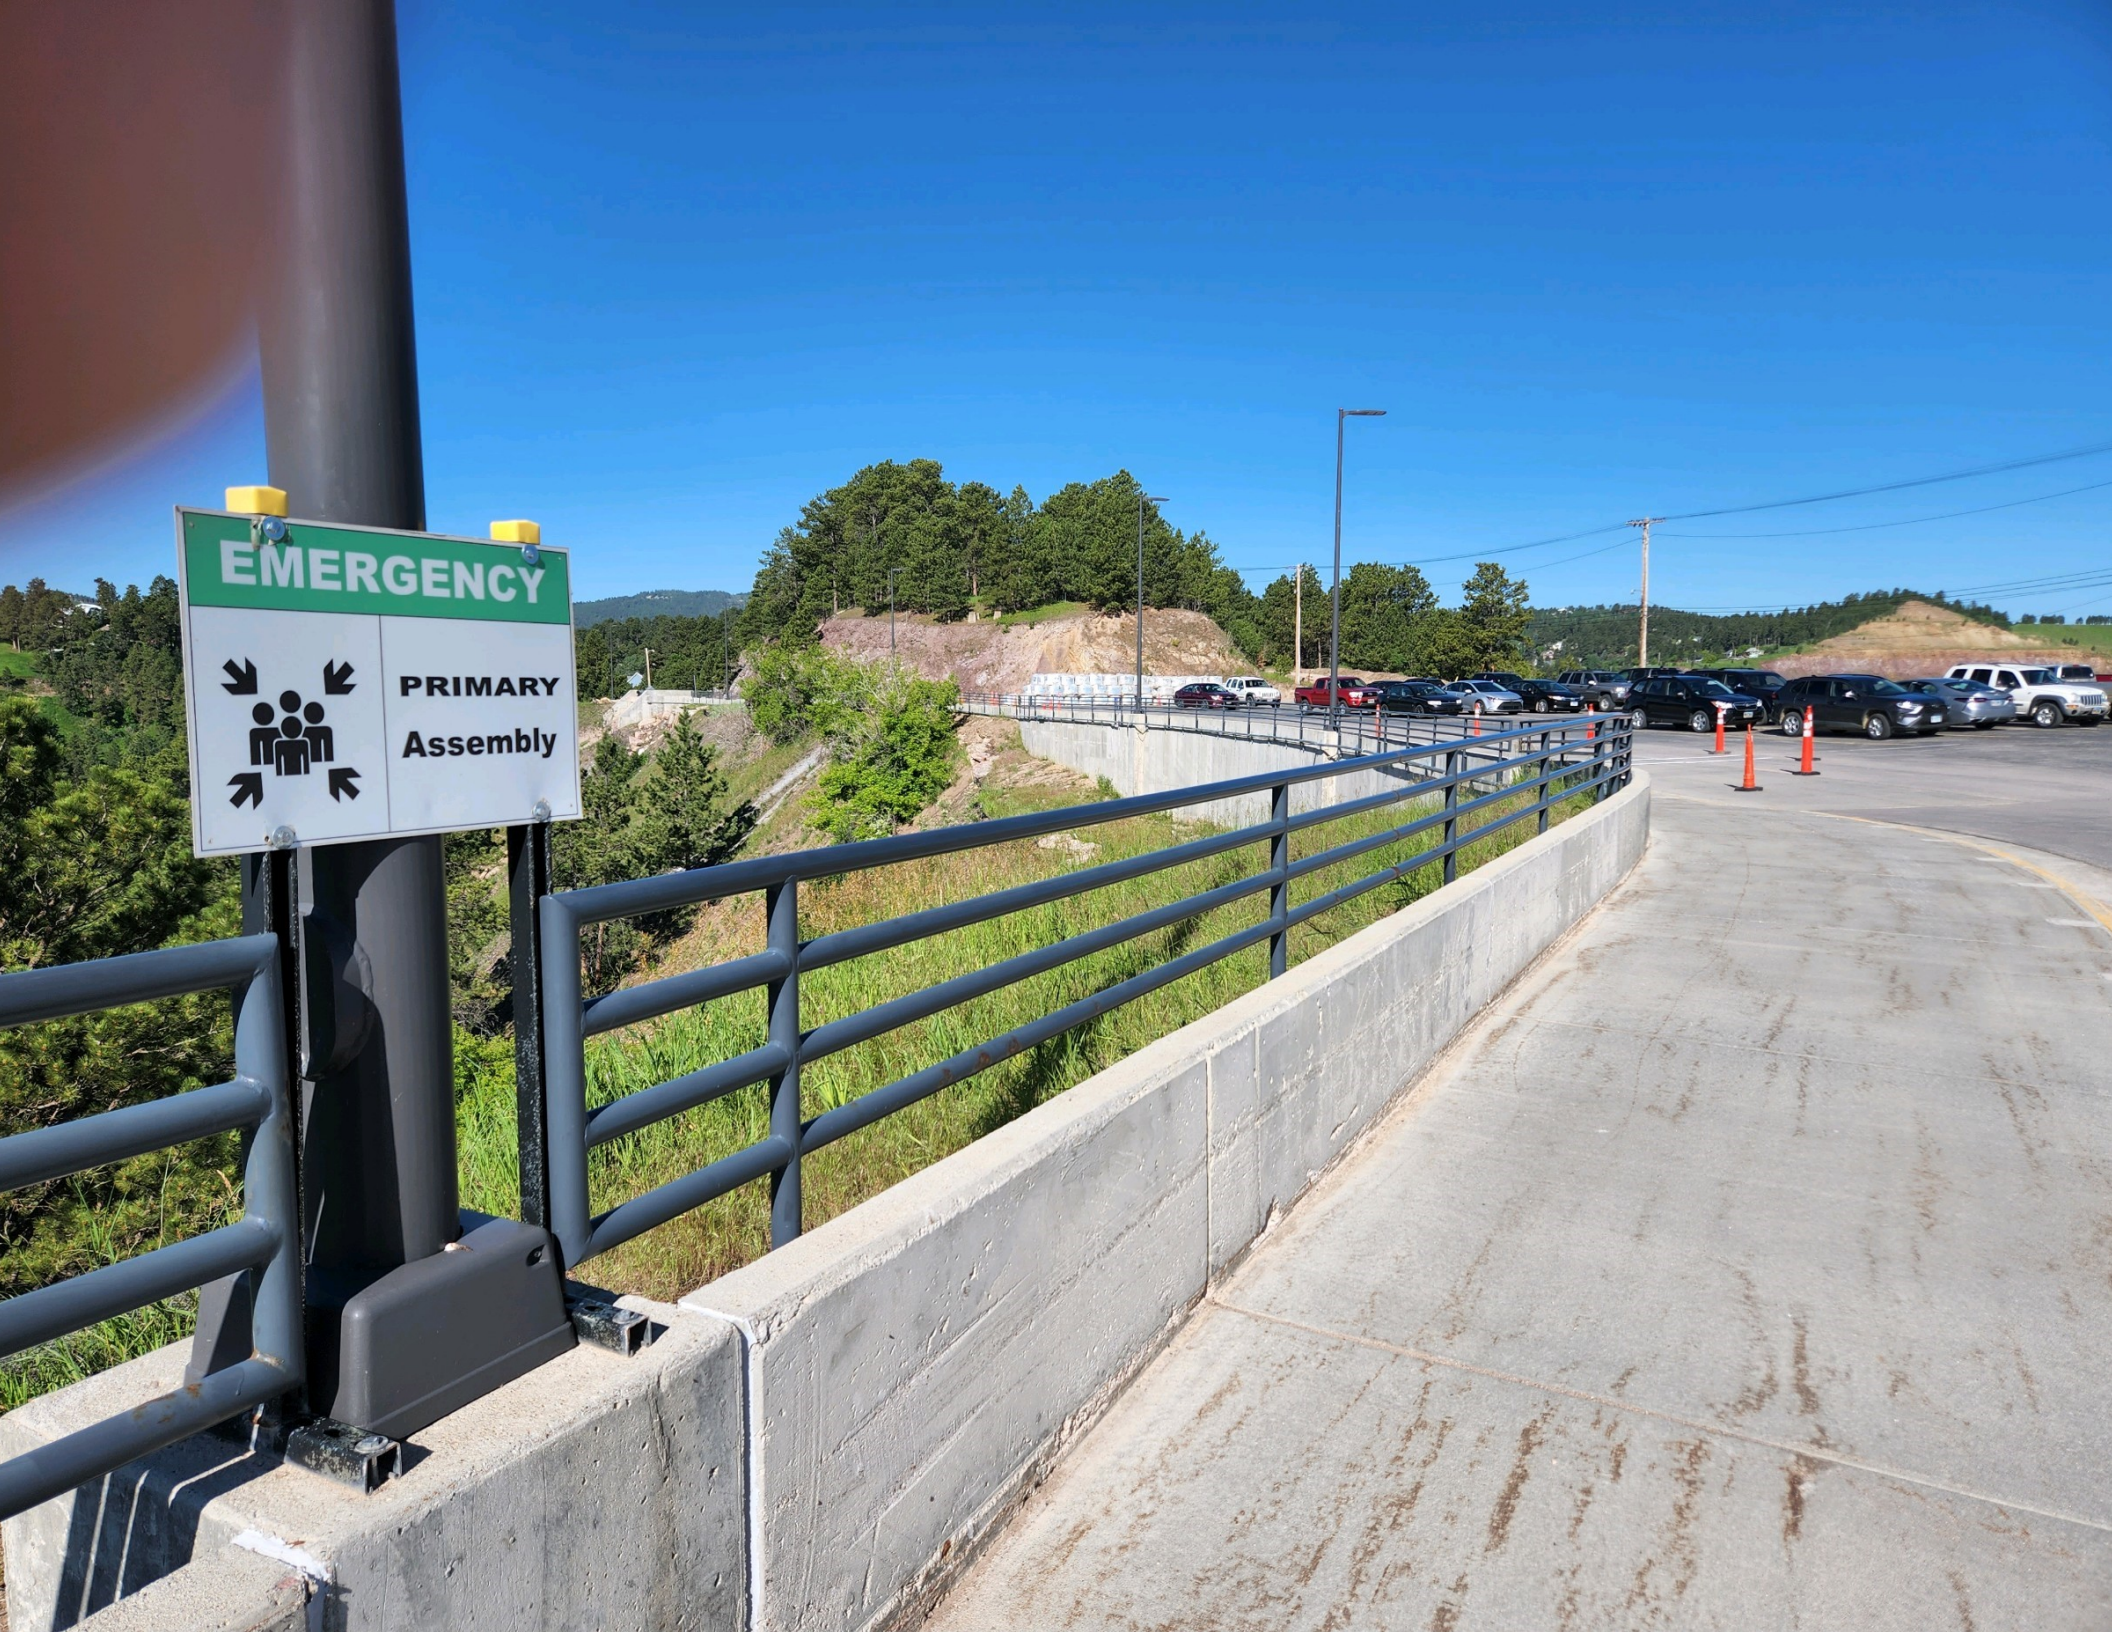
3. Picture 5: Shows the next section that runs from the mid-point of the 2nd and 3rd light poles to the snow dump.
  - a. Section is 4 pipes that runs approximately 370 feet long
  - b. The pipes are 1.5 inches in diameter with up-rights spaced at about 6 to 8 feet apart
    - i. There are spaces between sections where the light poles are placed.
  - c. Majority of the paint conditions in this section are that the paint is dull with little corrosion.
4. Picture 6: Shows the details of the upright supports.
