ROSS HEADFRAME TROLLEY BEAM STRENGTHENING

SANFORD UNDERGROUND
RESEARCH FACILITY
LEAD, SOUTH DAKOTA

TROLLEY BEAM
PHOTOGRAPHS

S501

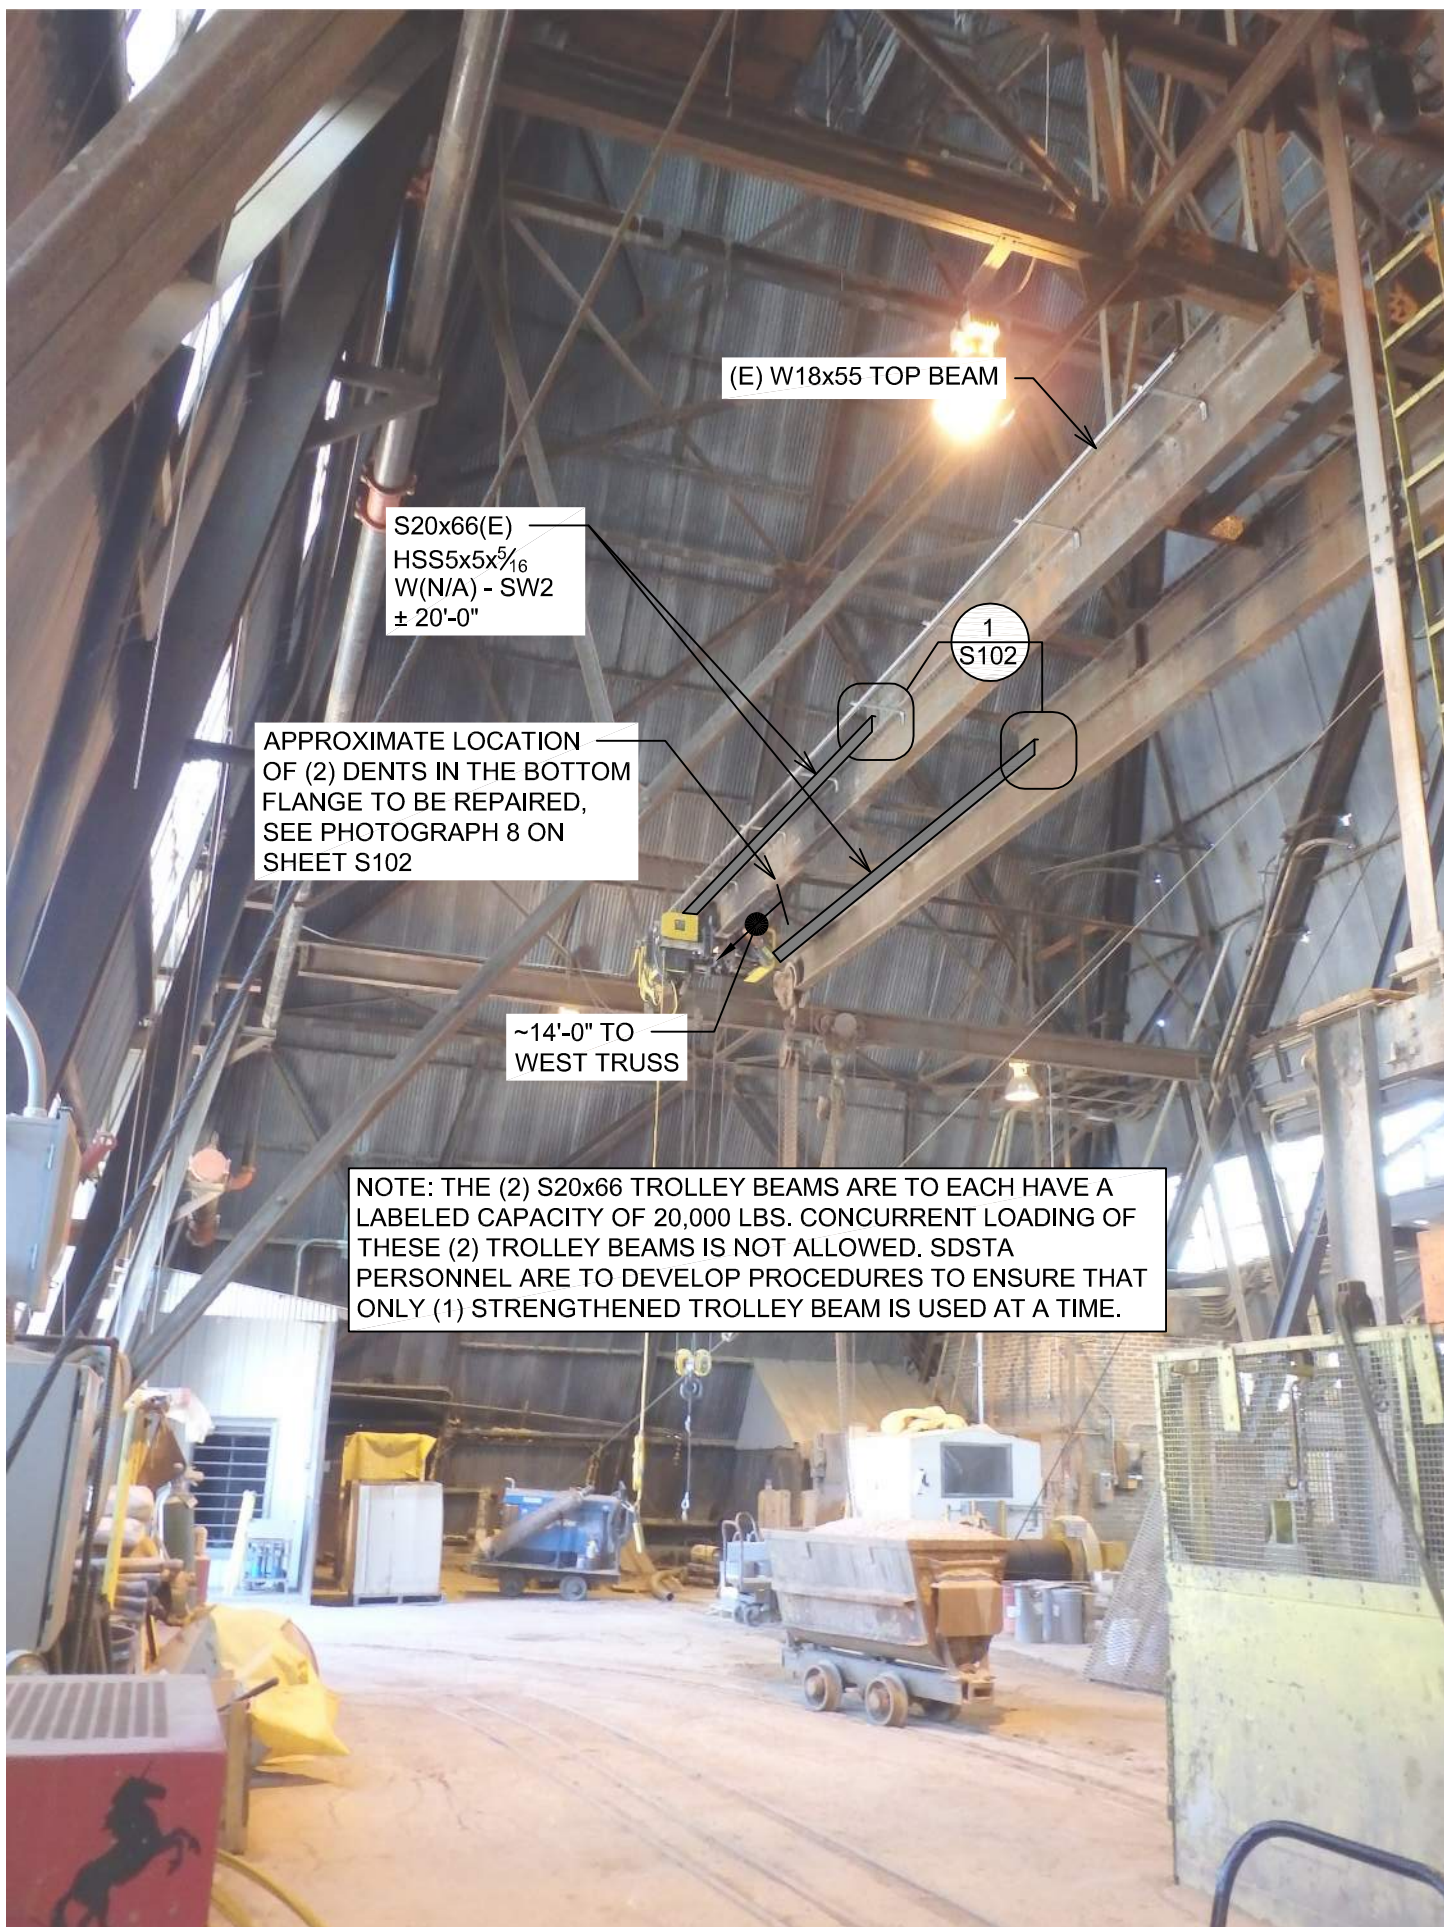
PHOTOGRAPH 01

- FOR DOUBLE ANGLE STRENGTHENING, SEE DETAIL 3 ON SHEET S501.
- THE TWO STRENGTHENED TROLLEY BEAMS SHOWN IN PHOTOGRAPH 1 ARE EACH TO HAVE A RATED LOAD CAPACITY OF 20,000 LBS. **CONCURRENT USE OF THE TROLLEY BEAMS IS NOT ALLOWED.**

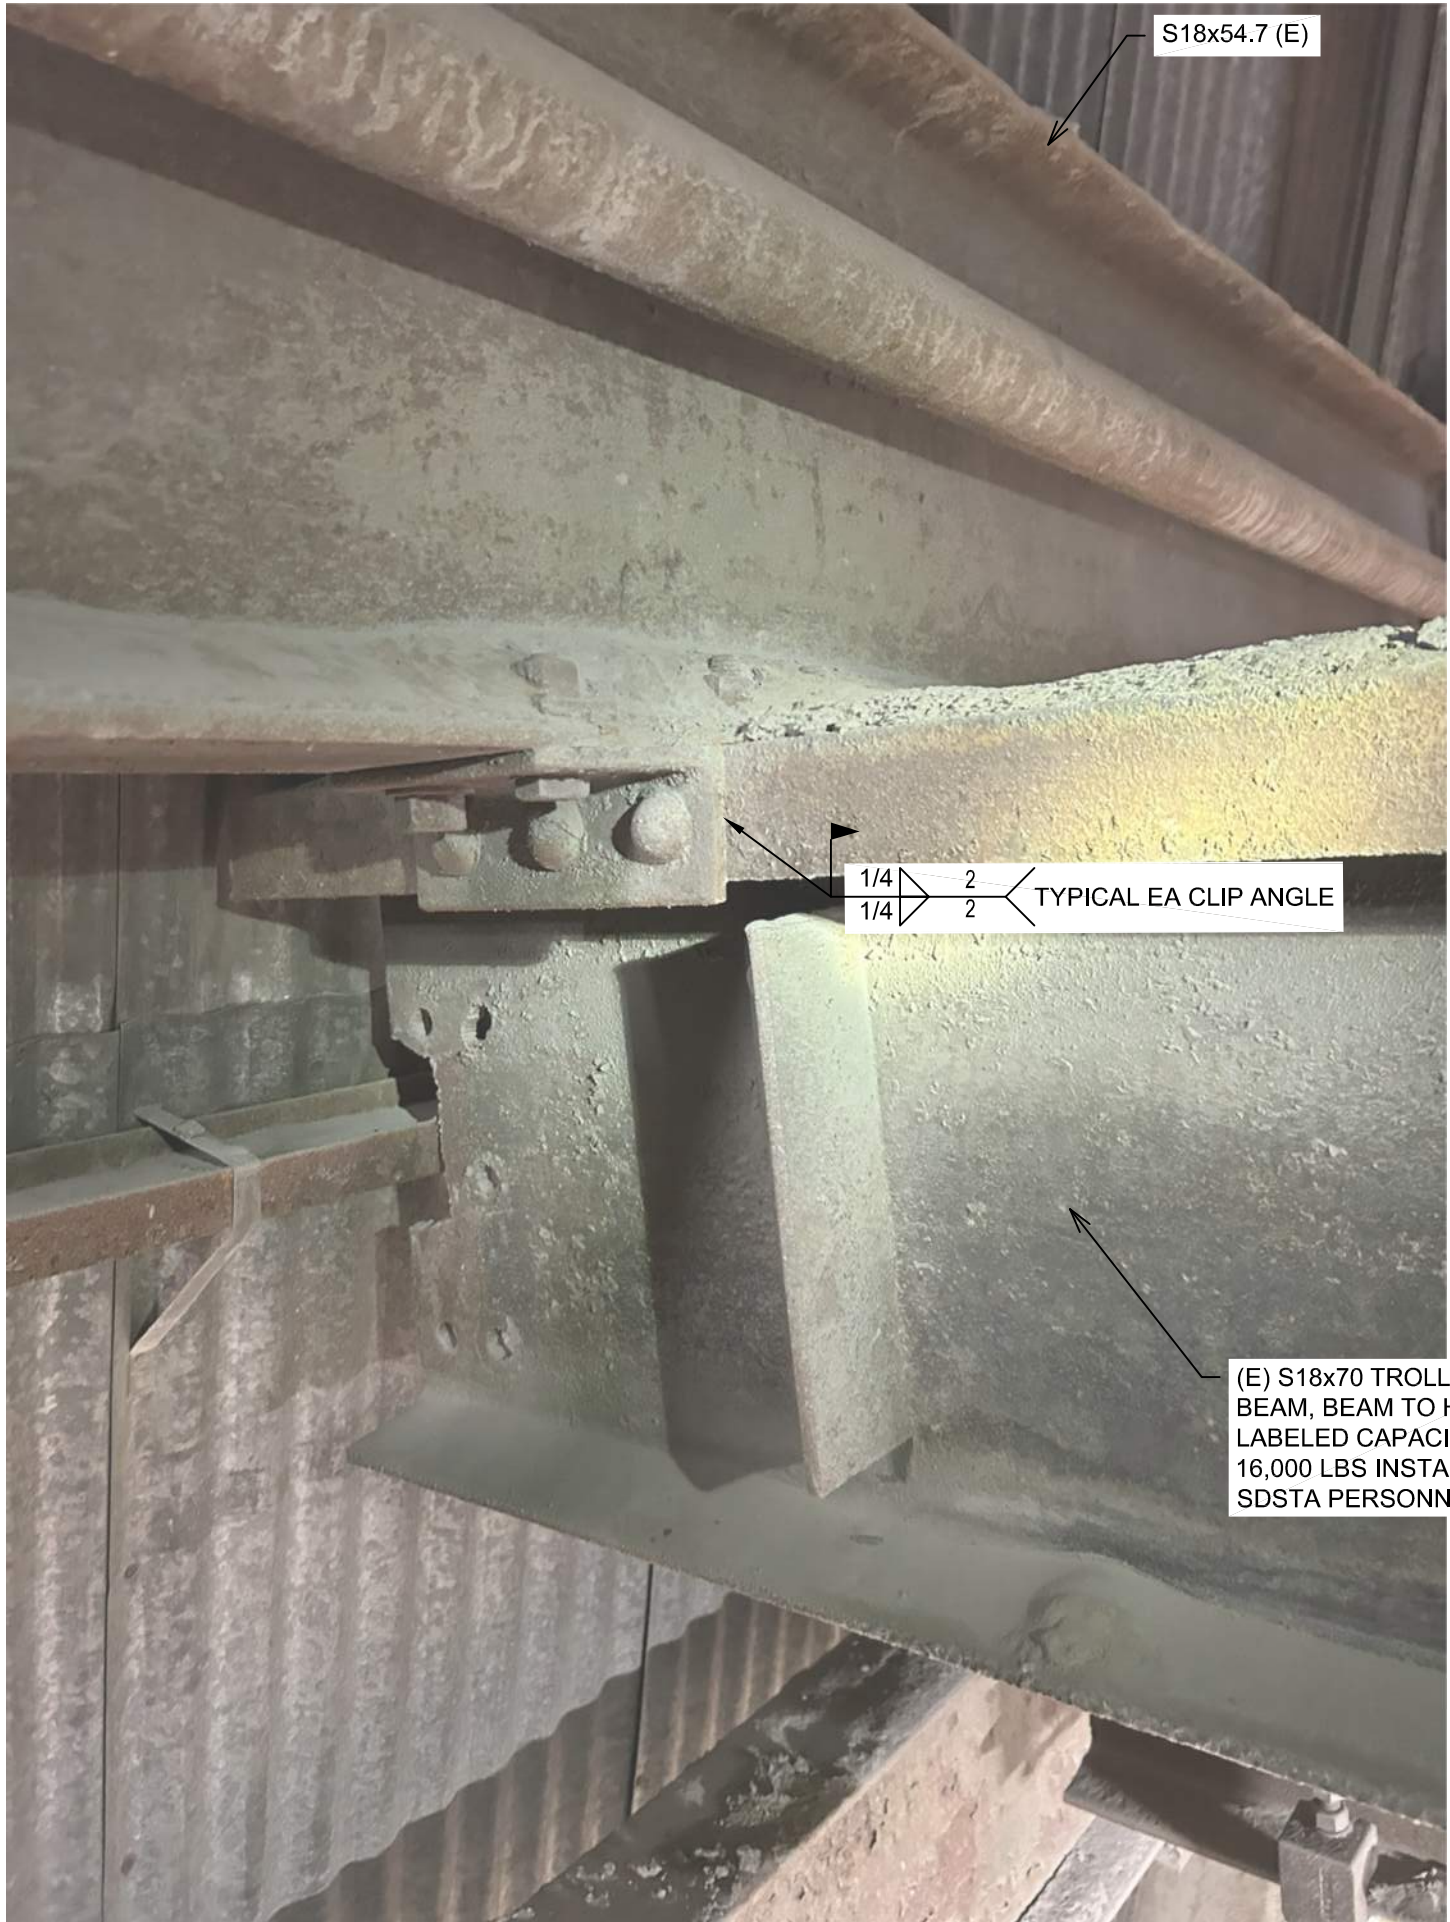
PHOTOGRAPH 07

NOTE: THIS PHOTOGRAPH APPLIES TO THE SOUTH END OF THE FAR EAST TROLLEY BEAM PRESENT WITHIN THE ROSS HEADFRAME. THE CONTRACTOR SHALL BE DIRECTED BY SDSTA TO THIS BEAM'S LOCATION. ONLY THE SOUTH END OF THIS BEAM REQUIRES REPAIRS.

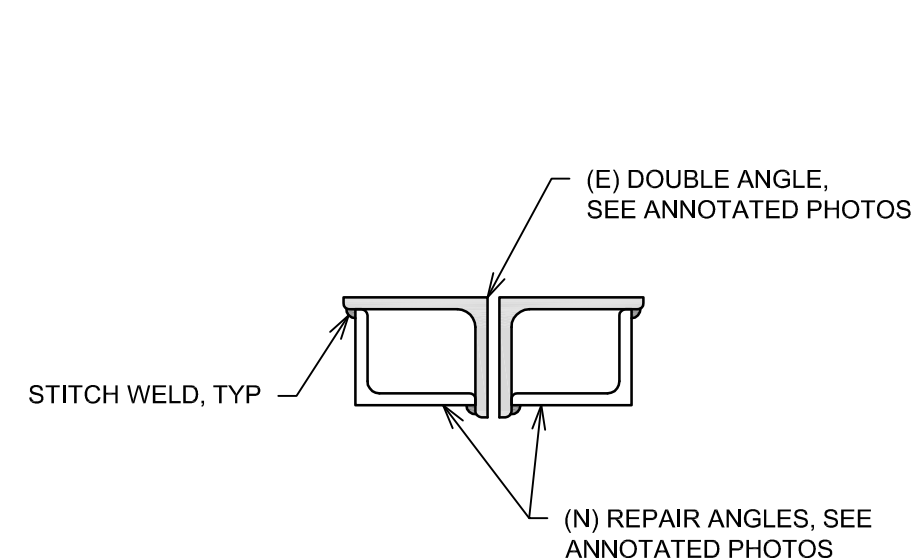
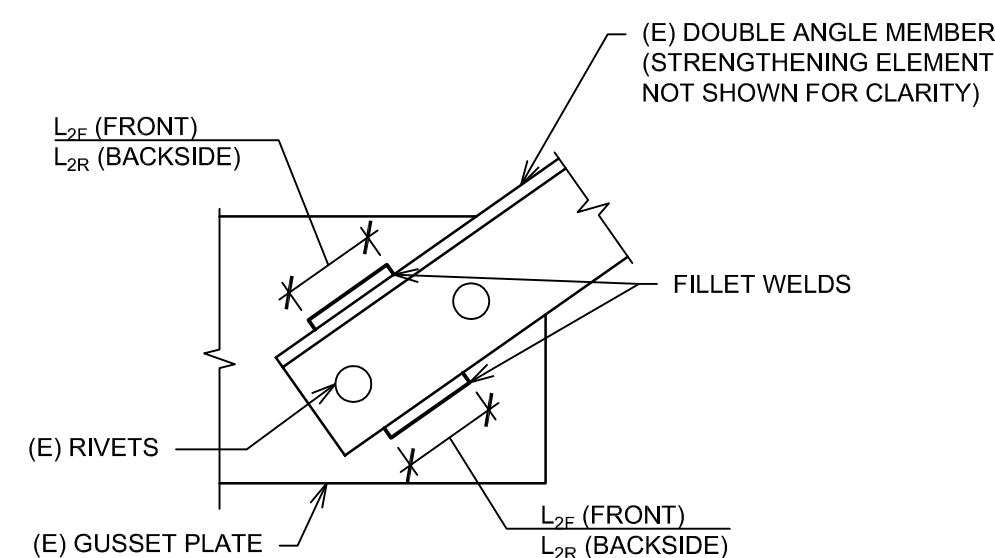
DOUBLE ANGLE REPAIR DETAIL

DOUBLE ANGLE END WELD TYPICAL DETAIL

NOTE: SEE DOUBLE ANGLE END WELD DETAIL ON SHEET S501.
